**Flood Control Project Maintenance  
Levee Inspections**  
**LMA District Cover Sheet**  
**Spring 2017 Levee Inspection Results**

**Reclamation District No. 0900 West Sacramento**

**Spring 2017 Levee Inspection Results**

Waterway			Bank	Unit Miles
Unit No. 01 Sacramento River			Right	7.70
	Spring (March - May)	Summer (June - August)	(September - November) Fall	Winter (December - February)
Unit Maintenance Rating (Fall Only)				
Date of Inspection	5/10/2017 - 5/10/2017			
DWR Inspector	Pavel Kazi			
Accompanied By	Chris Fogel RD 900

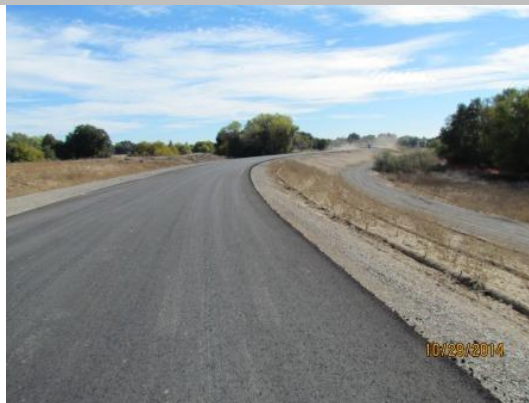
Photo 1 of 1 : SP\_2017\_RD0900\_230\_1\_20170327\_00001.jpg

View of the new setback levee looking downstream during fall 2014 inspection.

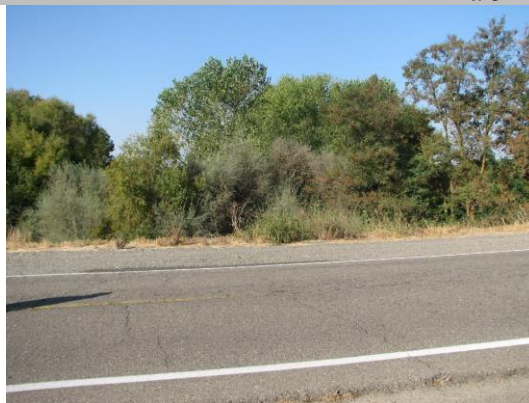
Photo 1 of 3 : UCIP\_SP\_2017\_37665\_68376.jpg

LM Start	2.15	Rating **	M	Issue No.	971
LM End	2.15	Issue Type +	En	Location *	CR
Category	Supplemental			GPS Latitude/Longitude	
				Start	End
Item	DWR UCIP Field Study			38.556994 °	38.556994 °
				-121.516843 °	-121.516843 °
DWR ID					
Comment Code					
Inspector Comment					
FS_ID:37665 DS_ID:17772 EP_NO: N/A Repair Type: Non-Urgent Crossing Status: Found UCIP Comments: Dense vegetation limits the inspector's visibility to identify signs of pipe failure (leaks) along the slope. Recommend removing vegetation along pipe alignment to conduct proper inspection of structure and appurtenances. FIELD_STRUCT_DESC: 42-inch pipeline through the levee 21.5 feet below the crown. Slide gate in concrete riser on the waterward slope. Flap gate on the waterward end. FS Date: 10/6/2009

View of levee crown at crossing.

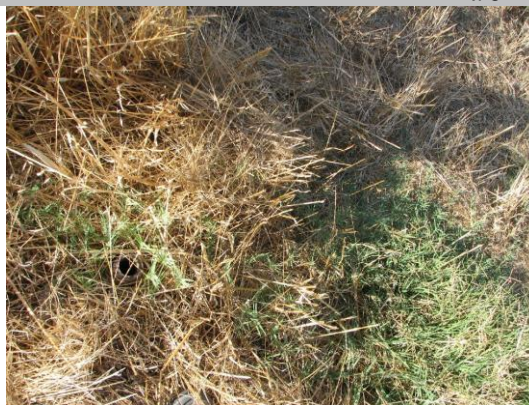
Photo 2 of 3 : UCIP\_SP\_2017\_37665\_68375.jpg

Air vent visible through dense vegetation.

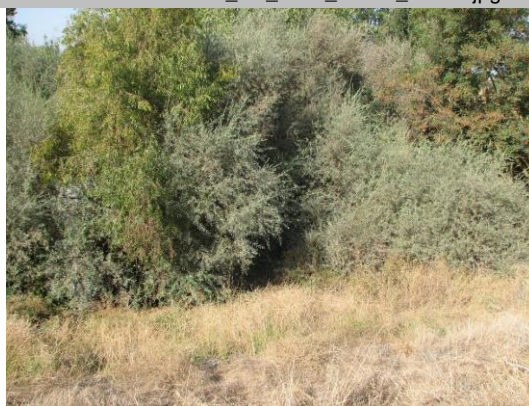
Photo 3 of 3 : UCIP\_SP\_2017\_37665\_68374.jpg

Dense vegetation along landward side.

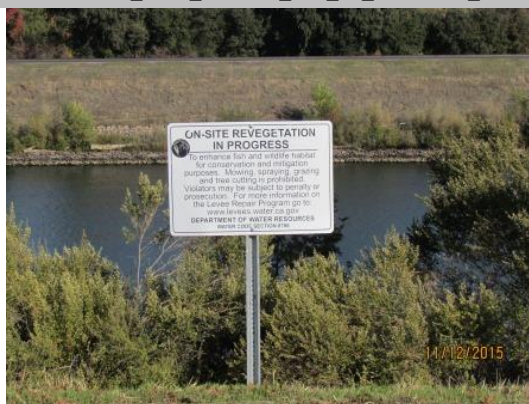
Photo 1 of 1 : SP\_2017\_RD0900\_230\_17\_20170327\_00011.jpg

LM Start	2.26	Rating **	A/W	Issue No.	17
LM End	3.72	Issue Type +	Ma	Location *	WS
Category	Earthen Levee			GPS Latitude/Longitude	
				Start	End
Item	Vegetation			38.555304 °	38.536946 °
				-121.516127 °	-121.519774 °
DWR ID	DWR_RD0900_01_s_2012_17				
Comment Code					
V8 : Environmental Requirements.					
Inspector Comment

View of the DWR environmental mitigation site.

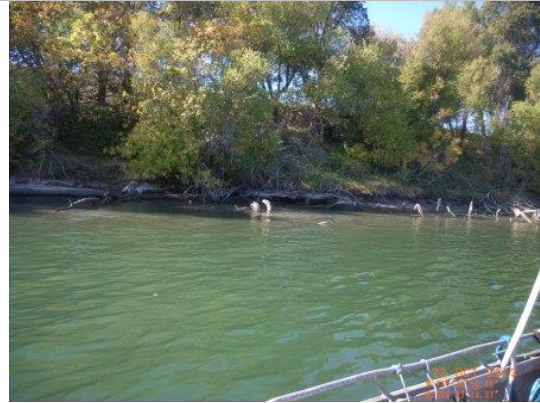
Photo 1 of 1 : SP\_2017\_RD0900\_230\_10\_20170327\_00008.jpg

LM Start	2.35	Rating **	M	Issue No.	10
LM End	2.47	Issue Type +	Ma	Location *	WS
Category	Supplemental			GPS Latitude/Longitude	
				Start	End
Item	2015 USACE Erosion Survey, DRAFT			38.554277 °	38.552504 °
				-121.515263 °	-121.514752 °
DWR ID	DWR_RD0900_01_s_2016_10				
Comment Code					
Inspector Comment					
2007 - Have good berm width with minor toe erosion. Close to the levee toe protection, but levee slope is steep. 2011 - New large erosion pocket. 2012 - Minor new erosion at the toe. 2015: No observed changes. [2015 Site ID: SAC_56-7_R]

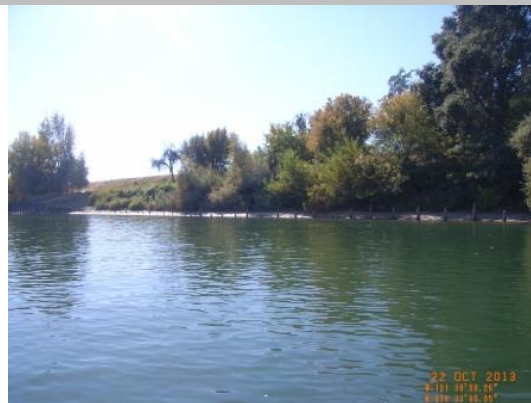
Photo 1 of 1 : SP\_2017\_RD0900\_230\_9\_20170327\_00007.jpg

LM Start	2.55	Rating **	M	Issue No.	9
LM End	2.64	Issue Type +	Ma	Location *	WS
Category	Supplemental			GPS Latitude/Longitude	
				Start	End
Item	2015 USACE Erosion Survey, DRAFT			38.551319 °	38.550090 °
				-121.514423 °	-121.513983 °
DWR ID	DWR_RD0900_01_s_2016_9				
Comment Code					
Inspector Comment					
1997 - Low berm is contributing to erosion. Old timber pile dikes above water parallel to bank. The upstream mitigation low berm causes a flow separation at the site. 1999 - Some new localized erosion with less than one foot of bank retreat. 2000 - Some new erosion at the upstream end. Fat toe deposits at toe. 2003 - Some new erosion upstream, but have a wide berm. 2011 - Minor new erosion at toe. 2015: No observed changes. [2015 Site ID: SAC 56-5 R]

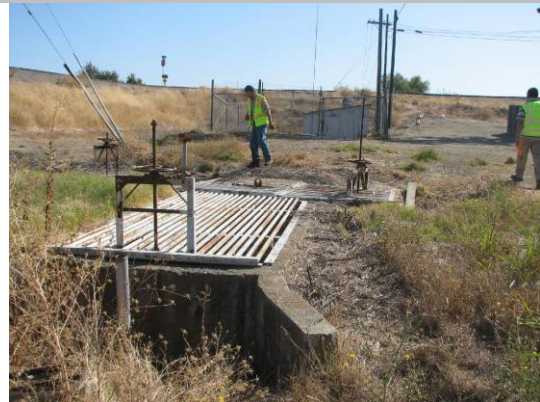
Photo 1 of 3 : UCIP\_SP\_2017\_37668\_68391.jpg

View of concrete structure located on landward side.

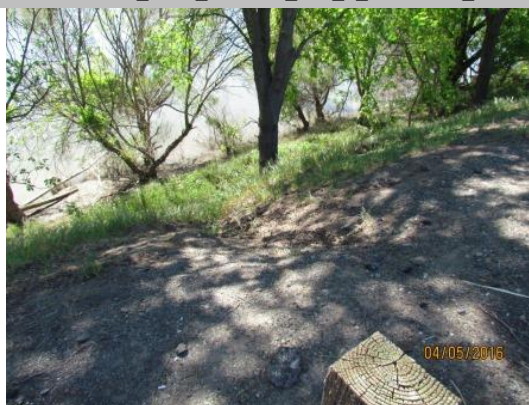
Photo 1 of 2 : SP\_2017\_RD0900\_230\_4\_20170327\_00003.jpg

Updated picture of the slope instability on the waterside of the levee looking downstream during spring 2016 inspection.

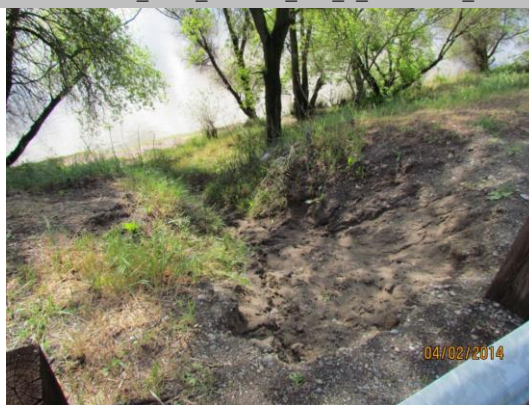
Photo 2 of 2 : SP\_2017\_RD0900\_230\_4\_20170327\_00004.jpg

A slope instability was found on the waterside slope of the levee looking downstream.

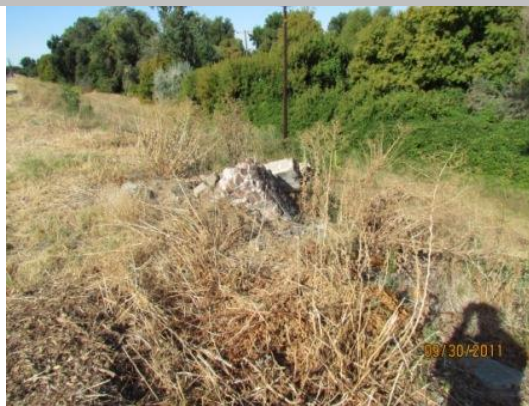
Photo 1 of 1 : SP\_2017\_RD0900\_230\_327\_20170327\_00019.jpg

Concrete debris were found on the landside of the levee looking upstream.

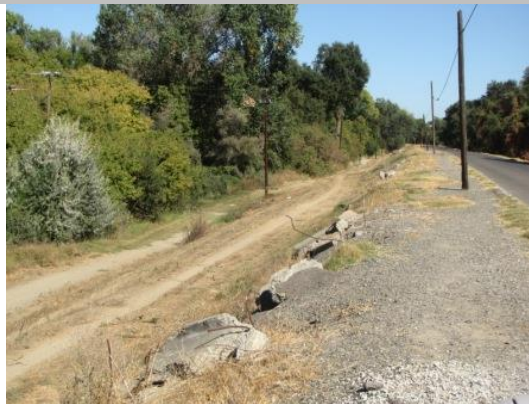
Photo 1 of 1 : SP\_2017\_RD0900\_230\_54\_20170327\_00014.jpg

View of concrete debris with metal looking upstream.

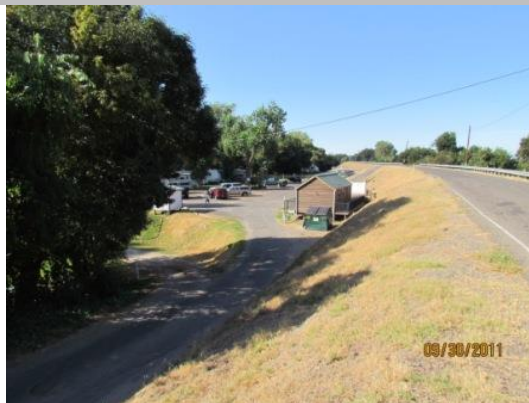
Photo 1 of 1 : SP\_2017\_RD0900\_230\_20\_20170327\_00012.jpg

View of Sherwood harbor's unpermitted properties on the waterside of the levee. The picture was taken from the crown looking upstream.

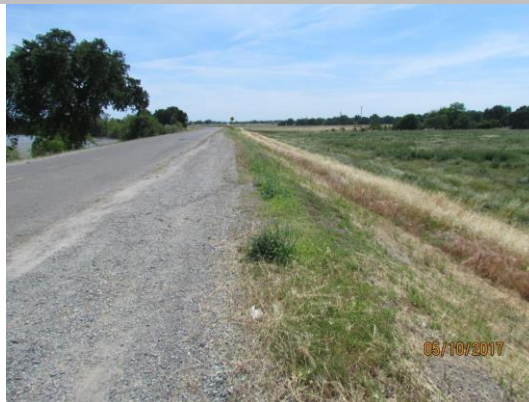
Photo 1 of 1 : SP\_2017\_RD0900\_230\_63\_20170511\_00031.jpg

View of vegetation on the landside of the levee.

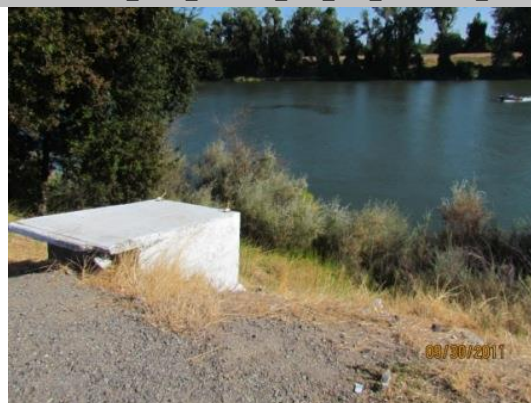
Photo 1 of 1 : SP\_2017\_RD0900\_230\_330\_20170327\_00020.jpg

Concrete anchor was found on the waterside slope of the levee looking upstream.

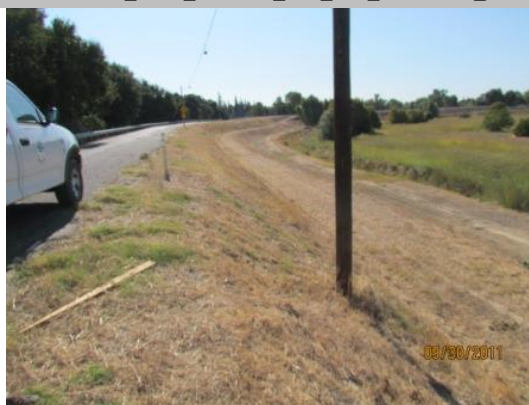
Photo 1 of 1 : SP\_2017\_RD0900\_230\_332\_20170327\_00021.jpg

View of the pole on the landside of the levee looking upstream.

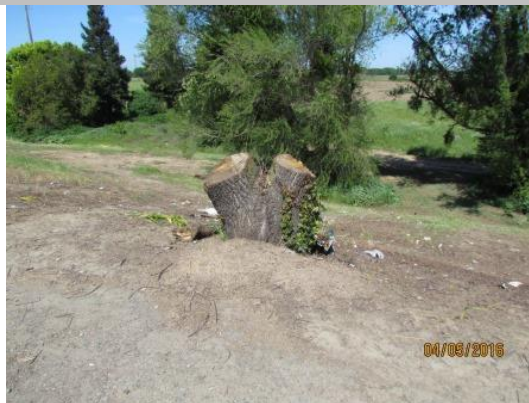
Photo 1 of 1 : SP\_2017\_RD0900\_230\_64\_20170327\_00018.jpg

View of a tree stump on the landside of the levee looking downstream.

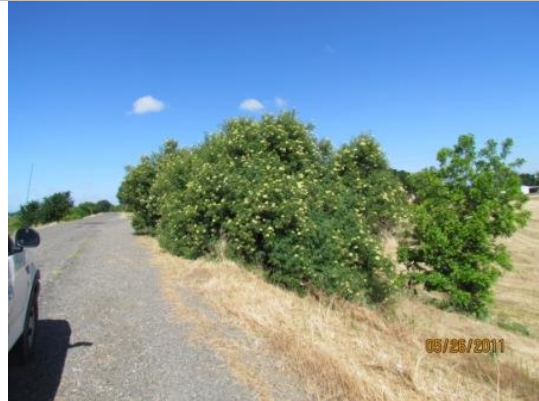
Photo 1 of 1 : SP\_2017\_RD0900\_230\_25\_20170327\_00013.jpg

Elderberry located on the landside of the levee obstructing the view. The picture was taken from the crown looking downstream.

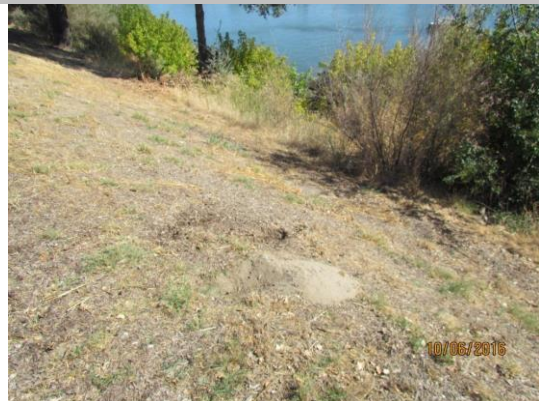
Photo 1 of 1 : SP\_2017\_RD0900\_230\_62\_20170327\_00017.jpg

View of a rodent hole on the waterside of the levee.

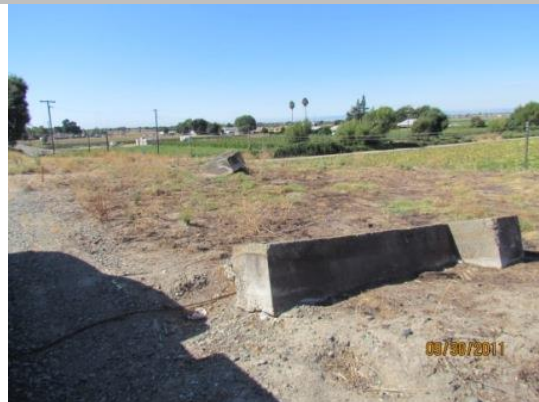
Photo 1 of 1 : SP\_2017\_RD0900\_230\_343\_20170327\_00023.jpg

Concrete debris from old rail road track was found on the landside of the levee looking upstream.

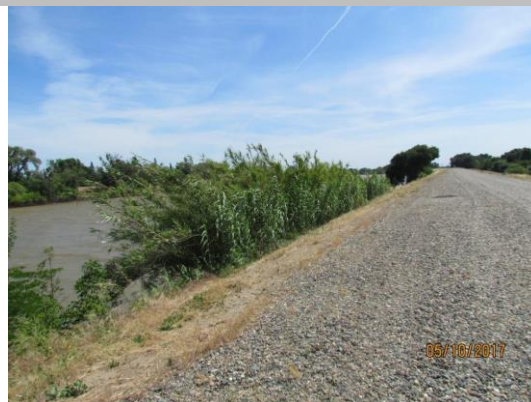
Photo 1 of 1 : SP\_2017\_RD0900\_230\_59\_20170511\_00032.jpg

View of the arundo on the waterside of the levee during spring 2017 inspection.

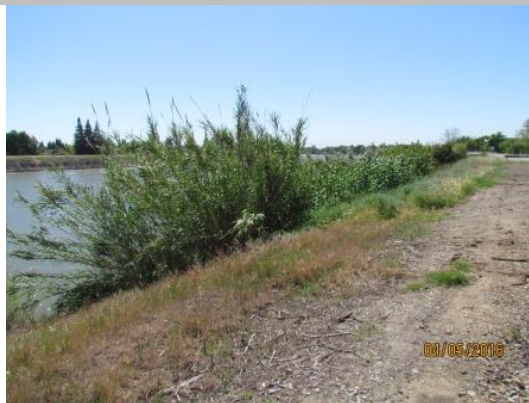
Photo 1 of 2 : SP\_2017\_RD0900\_230\_15\_20170327\_00009.jpg

Updated picture of the arundo on the waterside of the levee during spring 2016 inspection.

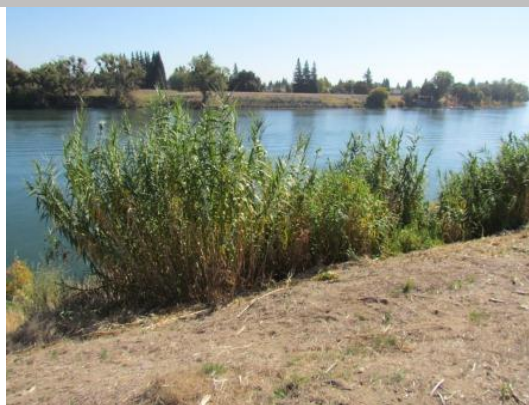
Photo 2 of 2 : SP\_2017\_RD0900\_230\_15\_20170327\_00010.jpg

View of arundo on the waterside of the levee looking downstream.

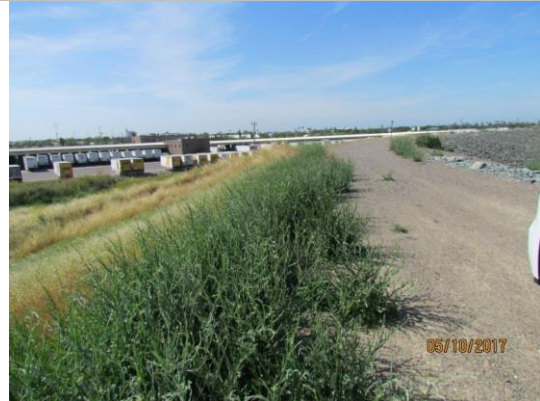
Photo 1 of 1 : SP\_2017\_RD0900\_231\_40\_20170511\_00043.jpg

View of the vegetation on the landside of the levee. Spring 2017

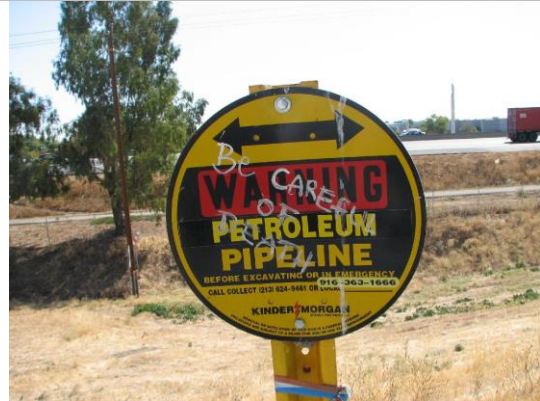
Photo 2 of 3 : UCIP\_SP\_2017\_41825\_72724.jpg

Marker of petroleum pipeline unable to confirm permit--there are 3 gas line in desk study records for gas line but none for Kinder Morgan.

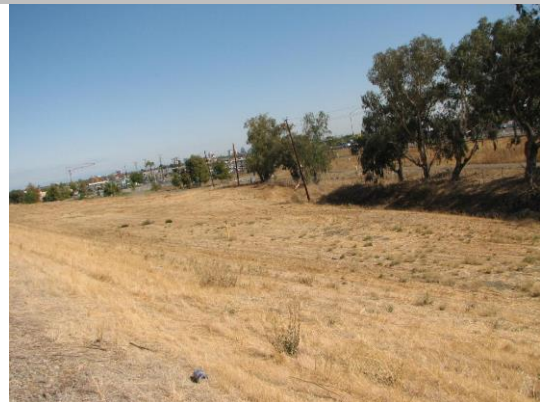
Photo 3 of 3 : UCIP\_SP\_2017\_41825\_72723.jpg

Additional marker visible on landward side--unable to confirm if line is tied to other marker near levee shoulder.

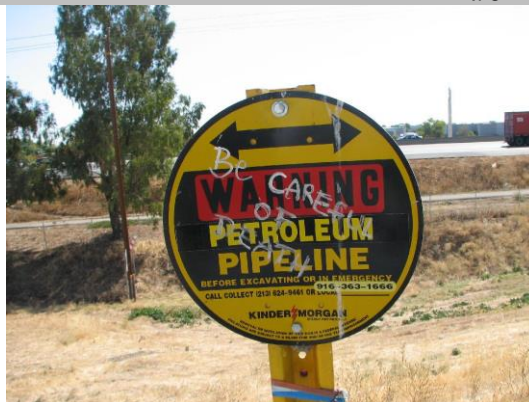
Photo 2 of 3 : UCIP\_SP\_2017\_41826\_72721.jpg

Marker of petroleum pipeline unable to confirm permit--there are 3 gas line in desk study records for gas line but none for Kinder Morgan.

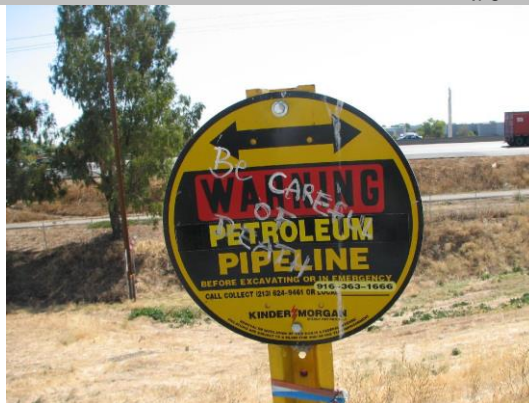
Photo 2 of 3 : UCIP\_SP\_2017\_41824\_72727.jpg

Marker of petroleum pipeline unable to confirm permit--there are 3 gas line in desk study records for gas line but none for Kinder Morgan.

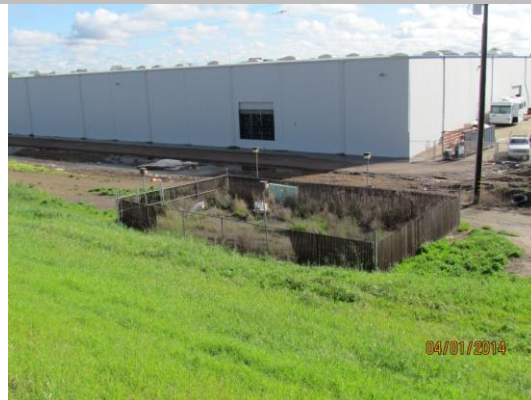
Photo 1 of 1 : SP\_2017\_RD0900\_231\_5\_20170327\_00001.jpg

View of the water well on the landside toe of the levee looking upstream.

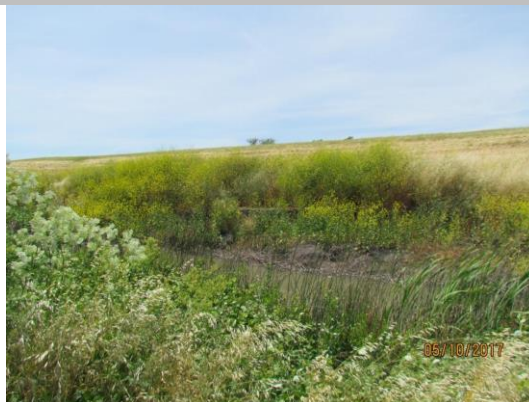
Photo 1 of 2 : SP\_2017\_RD0900\_231\_42\_20170511\_00047.jpg

View of an erosion on the landside toe of the levee at levee mile 3.98.

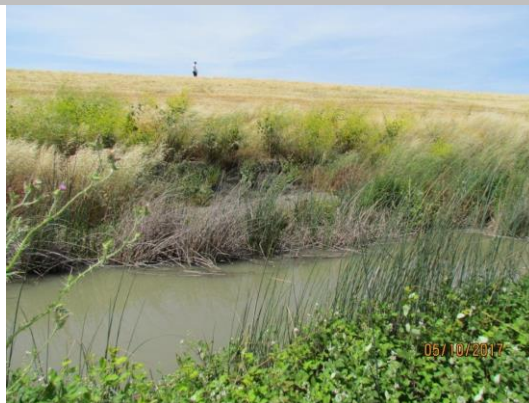
Photo 2 of 2 : SP\_2017\_RD0900\_231\_42\_20170511\_00048.jpg

View of an erosion on the landside toe of the levee at levee mile 3.92.

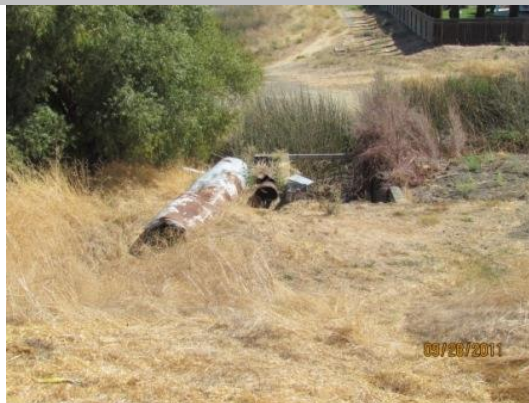
Photo 1 of 1 : SP\_2017\_RD0900\_231\_15\_20170327\_00002.jpg

Abandon pipes and debris was found on the landside of the levee looking upstream.

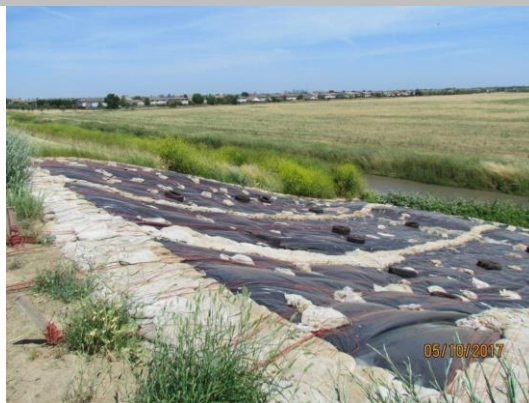
Photo 1 of 1 : SP\_2017\_RD0900\_231\_43\_20170511\_00046.jpg

View of a slope instability covered by raincoat on the landside slope of the levee looking upstream. Spring 2017

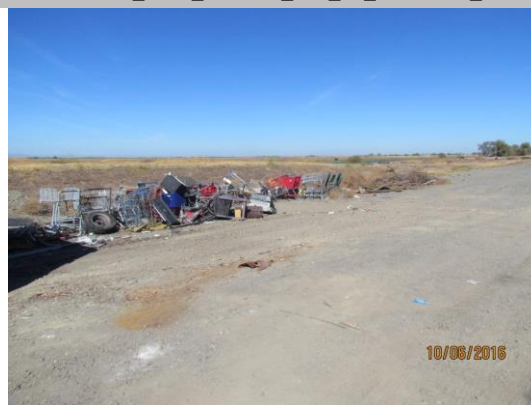
Photo 1 of 1 : SP\_2017\_RD0900\_231\_45\_20170327\_00003.jpg

View of debris on the landside shoulder of the levee looking upstream.

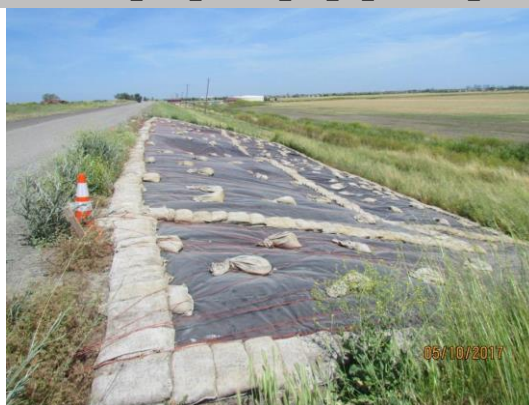
Photo 1 of 2 : SP\_2017\_RD0900\_231\_41\_20170511\_00044.jpg

View of a slope instability covered by a raincoat on the landside of the levee looking upstream. Spring 2017

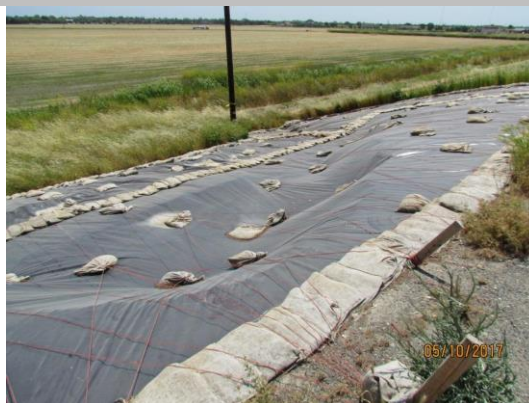
Photo 2 of 2 : SP\_2017\_RD0900\_231\_41\_20170511\_00045.jpg

An alternate view of the slope instability on the landside of the levee looking downstream. Spring 2017
